Failure of San-men Gorge Reservoir Project, China

December 1967

FAILURE OF SAN-MEN GORGE RESERVOIR PROJECT, CHINA

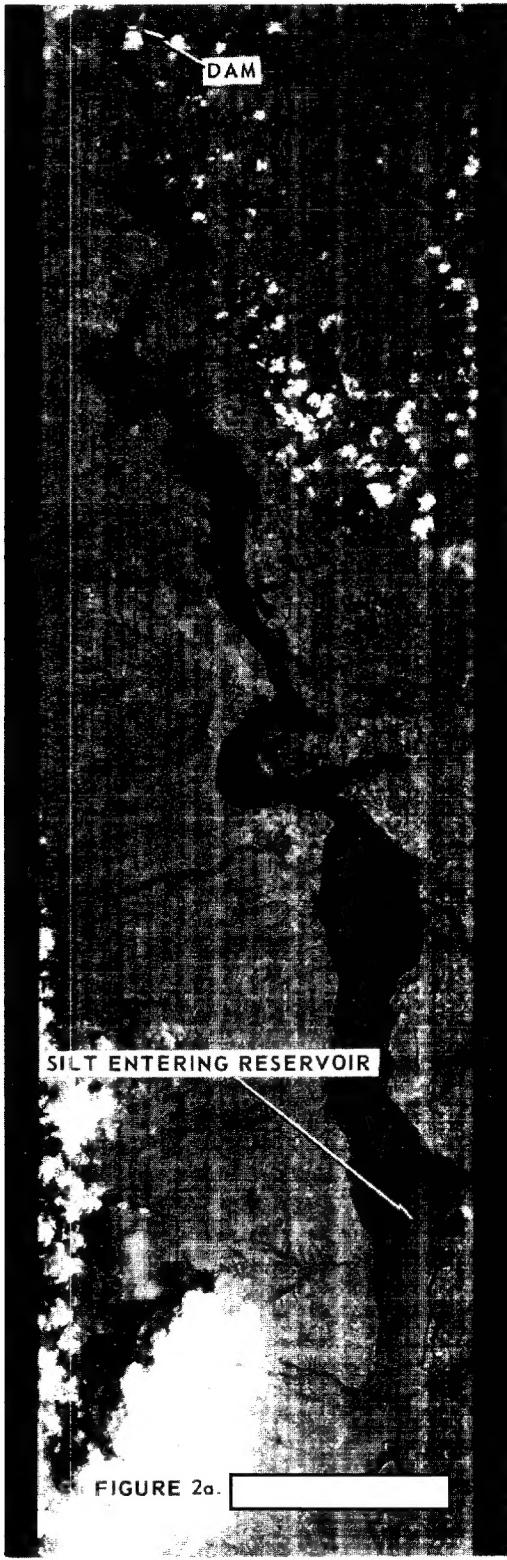
FIGURE 2a.

The San-men Gorge Reservoir is situated in a deep canyon on the middle reaches of the Yellow River (Figure 2a). When filled, the reservoir extends 55 nautical miles (nm) upstream from the dam at San-men Gorge to the confluence of the Yellow and Wei Rivers. The reservoir dam is reported to be 350 feet high and is approximately 3,000 feet long. Its capacity is reported to be over 28 million acre feet.

Photography [redacted] revealed that the reservoir was partially filled. The tone of the water entering the reservoir indicated that it was carrying a large amount of silt (Figure 2a), and the volume of water in the river downstream from the dam appeared to have been reduced.

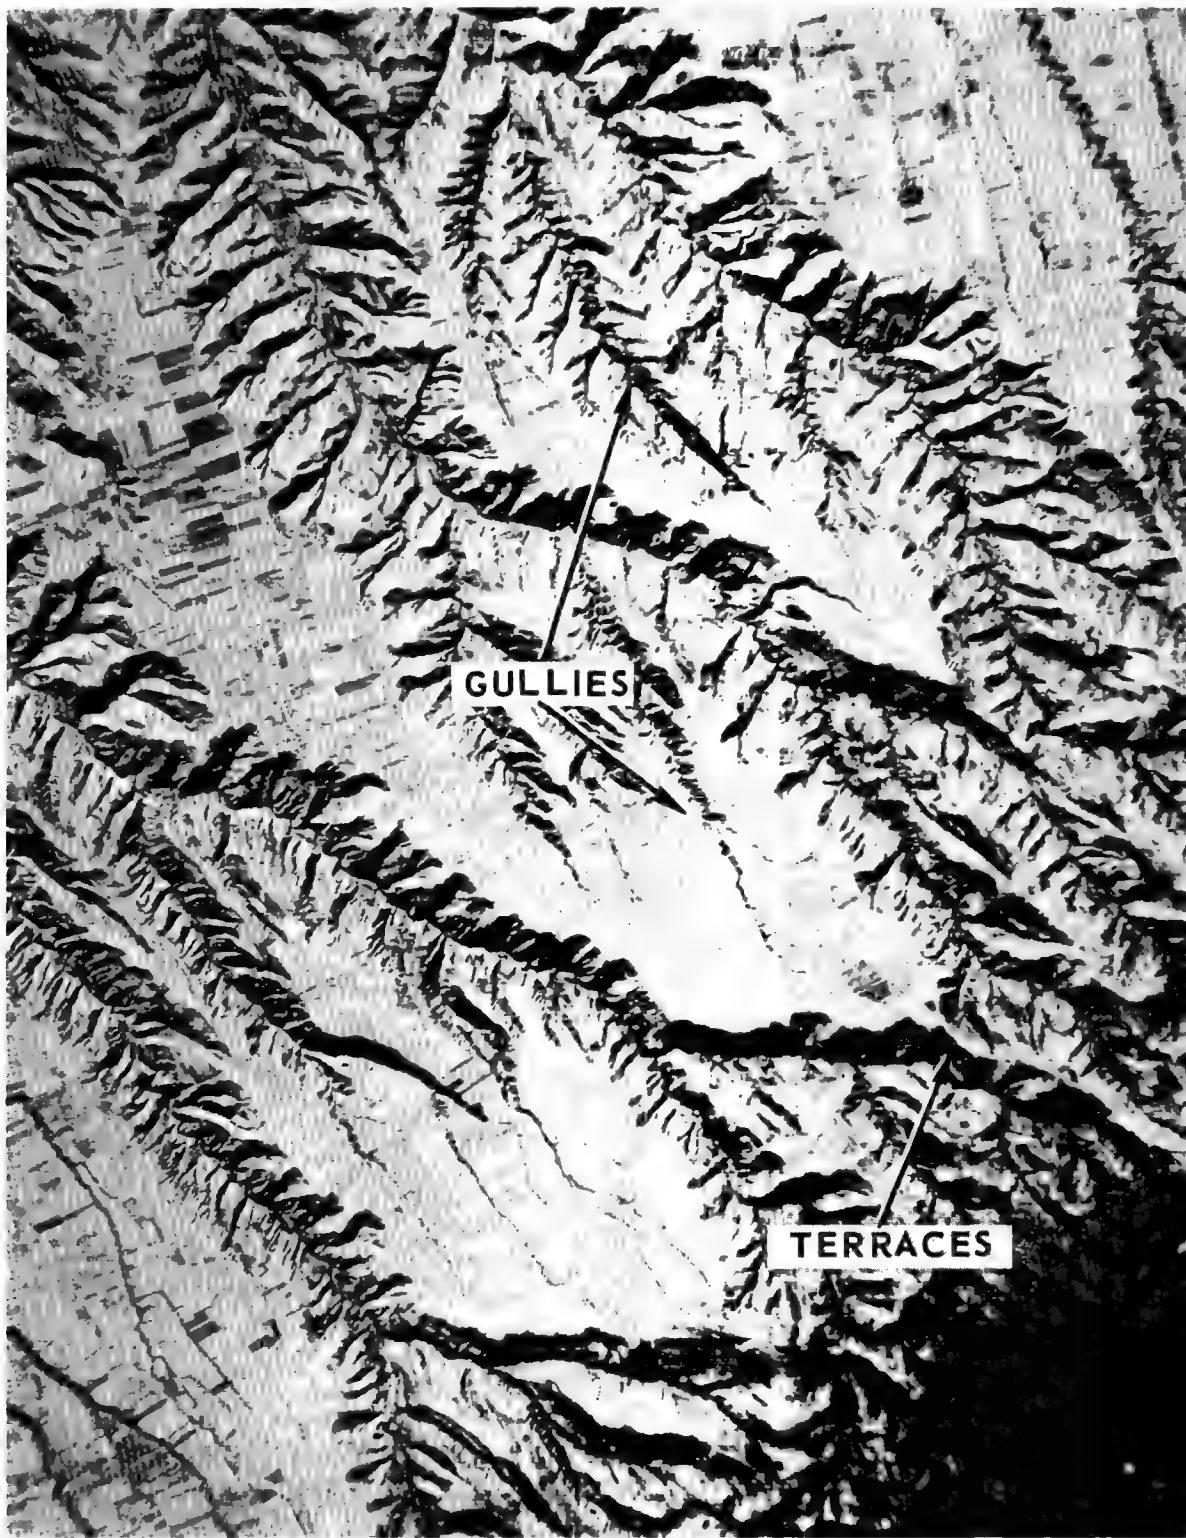
The Loess Plateau is an old dissected peneplain which has been covered by a layer of wind deposited dust varying from a few feet to over 250 feet thick. This light unconsolidated loess is commonly overtilled, and without its natural vegetation cover and under the influence of heavy summer downpours, is extremely susceptible to erosion. Photography reveals (Figure 5) that natural vegetation covers less than five percent of the plateau, and that gully and sheet erosion occur over a large portion of the drainage area. With 65 percent of the total annual rainfall occurring in July, August, and September (Table 1), usually as heavy downpours, tremendous quantities of silt are being washed into the Yellow River.

FIGURE 5. ERODED LOESS.

The immediate task to reduce erosion in a watershed usually is to recreate the natural vegetation by aforestation and grass planting. Recent photography indicates that the Chinese have accomplished very little toward this first step of erosion control nor have they begun construction of silt control dams on the Yellow River and its important tributaries.

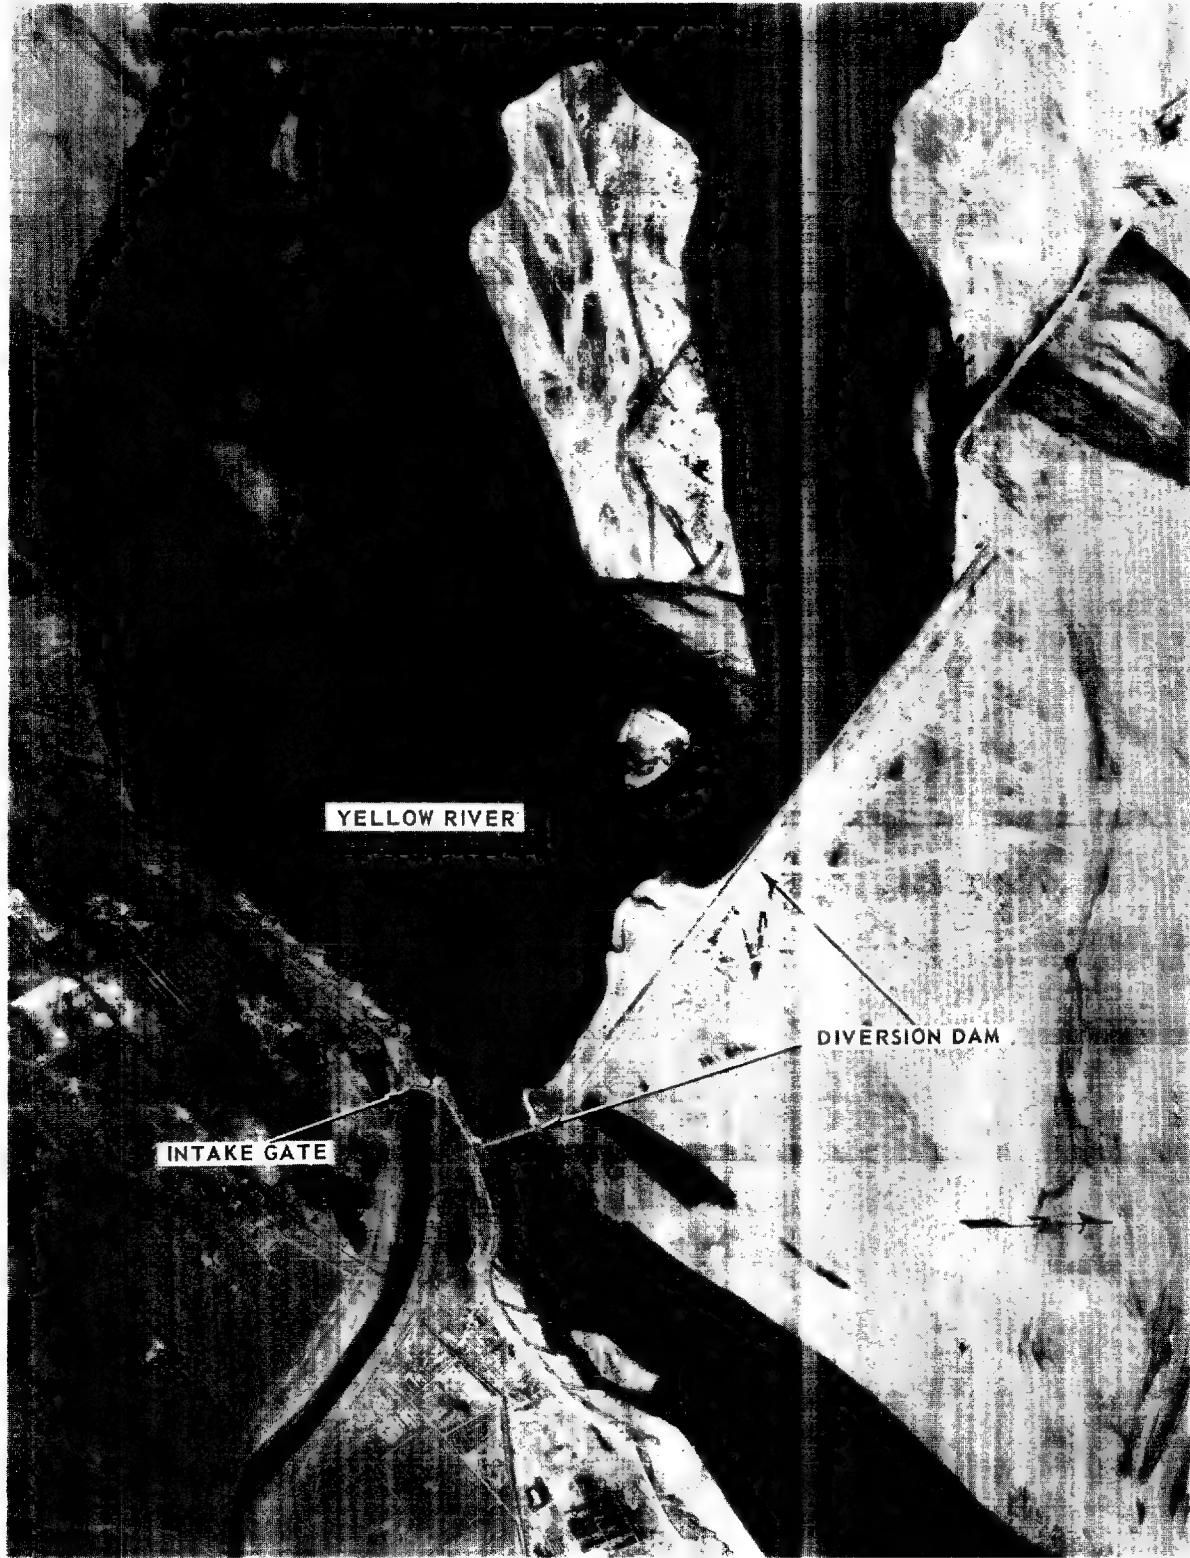
Photography [redacted] indicated the Chinese are having difficulty in obtaining a sufficient supply of water for the Cheng-chou and Lan-feng Irrigation Projects (Figures 6 and 8) located 130 and 210 nautical miles downstream from the dam. During this five year period the canal intake gates were photographed in both the wet and dry seasons, times when the river would normally be at its highest and lowest levels. Dates when the water was above or below the intake gates are given in Table 2. This table includes all available coverage from the date the dam was closed [redacted]. Since there is insufficient photographic coverage of the canal intake gates before the dam was closed, the extent of retrogression cannot be determined. It is evident, however, that only a small amount of water for irrigation is available during the wet season and that even less water is available during the winter wheat growing season of March, April, and May when evaporation generally exceeds rainfall in these irrigation projects. In addition, during the wet season of 1965, flood waters destroyed the major portion of the Cheng-chou Diversionary Dam located at 34-55N 113-36E (Figures 6 and 7). This further complicates the task of obtaining sufficient water for the Cheng-chou Irrigation project.

FIGURE 6. CHENG-CHOU CANAL INTAKE GATE.

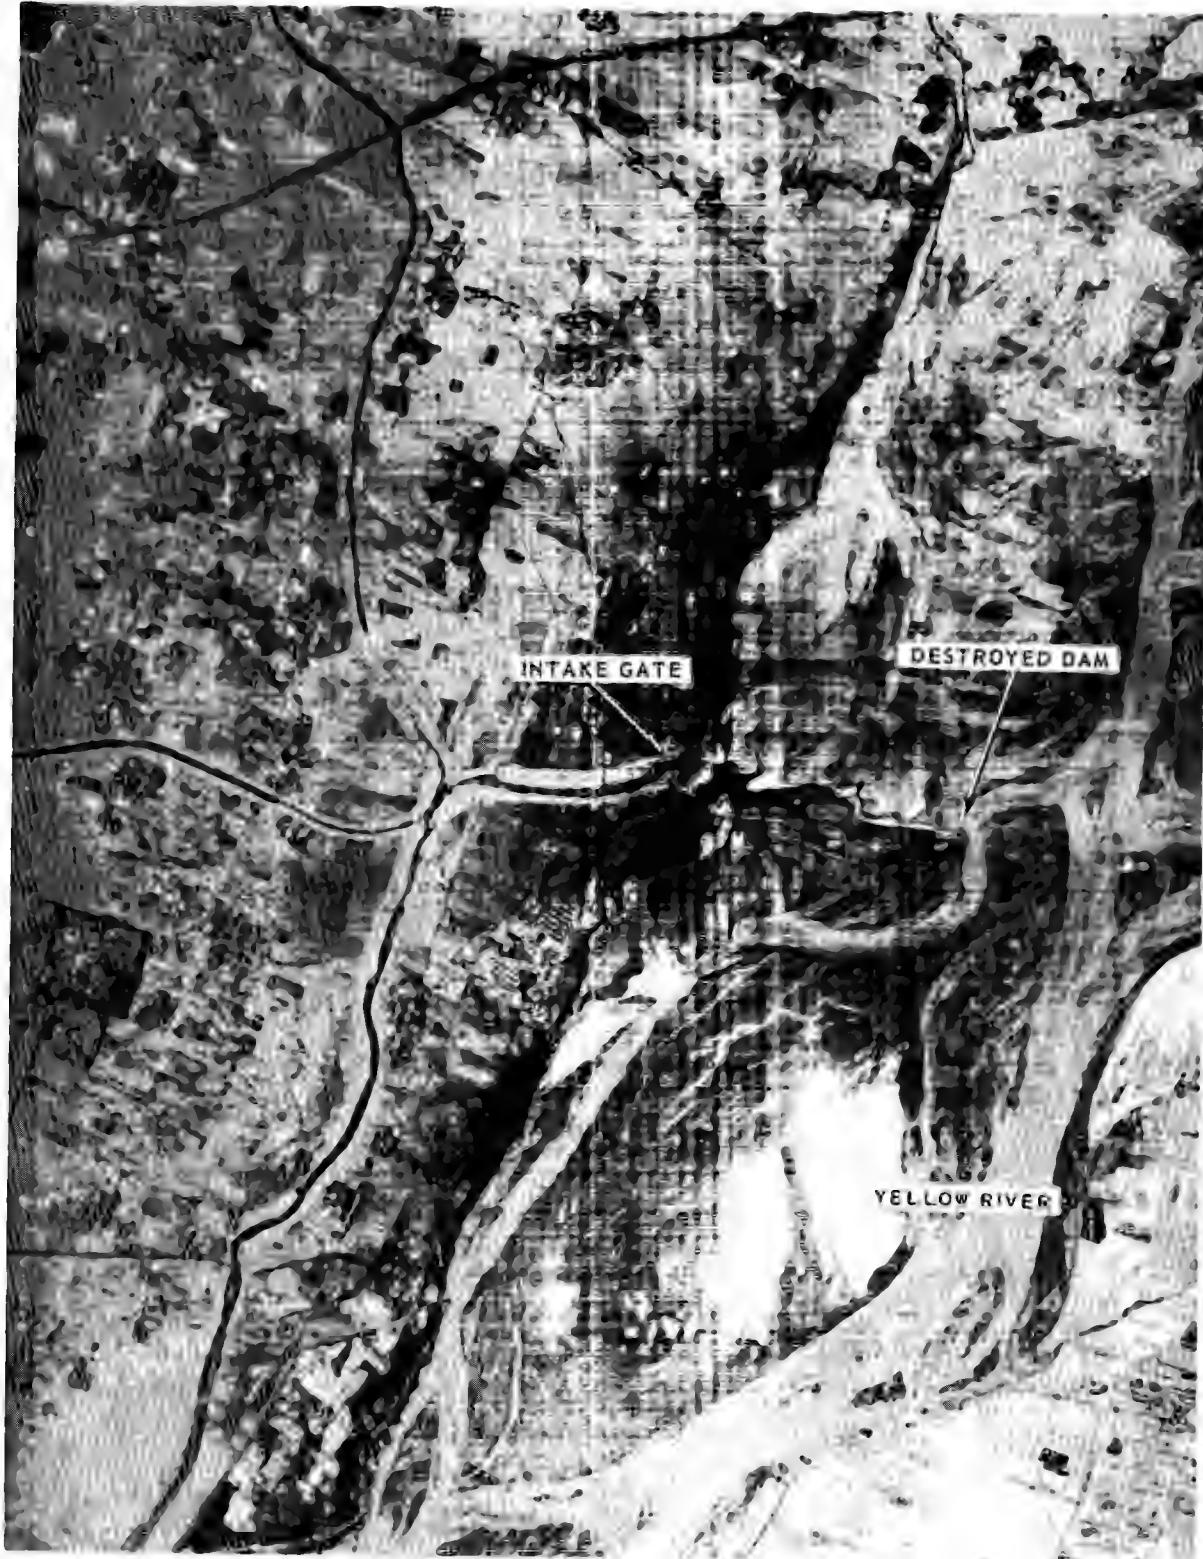
FIGURE 7. CHENG-CHOU CANAL INTAKE GATE.
